**Car Stereo
Service Bulletin**

Model: XR-7200

No. 119

Subject: No LCD Display

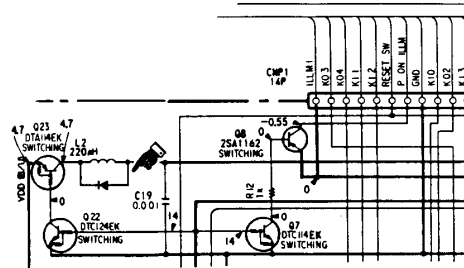
No display or incorrect display on the LCD.

Ringling generated on the LCD power line when turning on the power may ruin the LCD.

Solution: Add a diode as a shunt across L2 as shown:

Description	Part Number
Diode 1SS119	8-719-911-19
