Car Stereo  
Service Bulletin

**Model:** XE-8

**No.** 128

**Subject:** System With XE-8 Does Not Operate **Date:** May 8, 1989

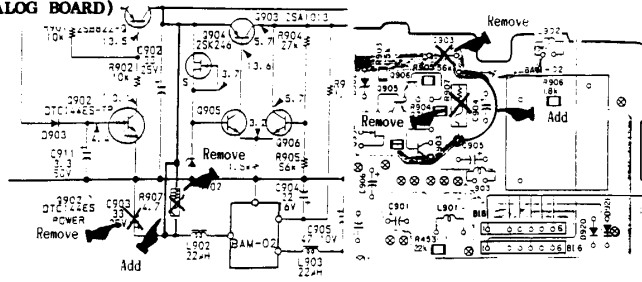
(ANALOG BOARD)

The entire system in the car does not operate. The symptoms on the XE-8 itself are:

1. Remains illuminated continuously.
2. Spectrum Analyzer display is fully lit. This is caused by the battery mirror circuit not turning on.

**Solution:** Change the following parts:

Ref. No.	Description	
	Former	New
R504	5.6k Ohm	47k Ohm
R515	5.6k Ohm	
R673	2.4k Ohm	3k Ohm
R705	10k Ohm	150k Ohm
R907	4.7 Ohm	Remove and Short-Circuit With Wire
C903	33uF/25V	Remove
D672 D673	----	Add 1SS199
----	----	Cut a Pattern
