Car Stereo Service Bulletin

Model: RM-X2/XK-8D

No. 134

Subject: XK-8D Cannot Be Operated With
RM-X2

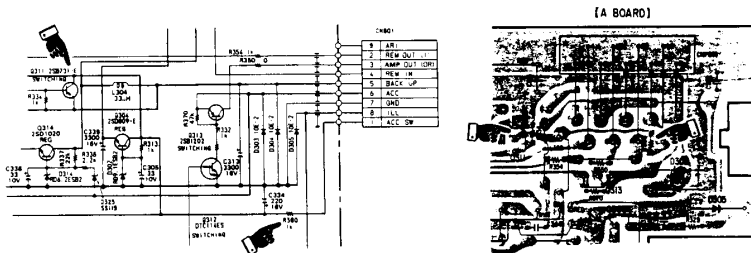
When an RM-X2 is connected with an XK-8D, it does not operate. The current which is supplied by the RM-X2 is insufficient for driving the XK-8D.

Solution: Please replace R380, Q311 as follows:

Ref. No.	Description		Part Number
	Former	New	
R380	1k Ohm	1 Ohm	1-249-447-11
Q311	2SB731	2SB1202	8-729-805-20
