**Car Stereo
Service Bulletin**

Model: XEC-1000

No.179

Subject: No Audio Or Buzzing/Engine Whine

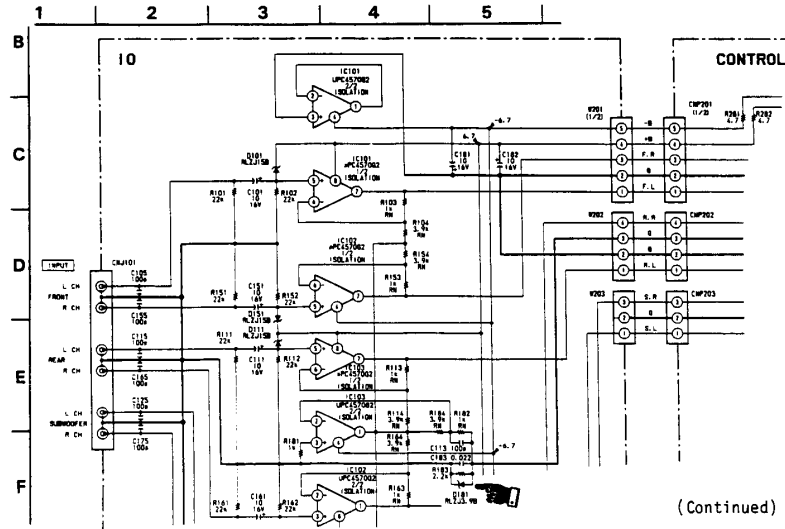
Solution: Remove D181 from the "IO" Board and inspect the Main Board for any open traces in the locations shown.

Ref. No.	Description	Board Location	Schematic Location
D181	Zener Diode PLZ-J15B	"IO" Board I-10	F-5
