**Car Stereo
Service Bulletin**

Model: CDX-R77/R79

No.190

Subject: IC301 Incorrectly Installed

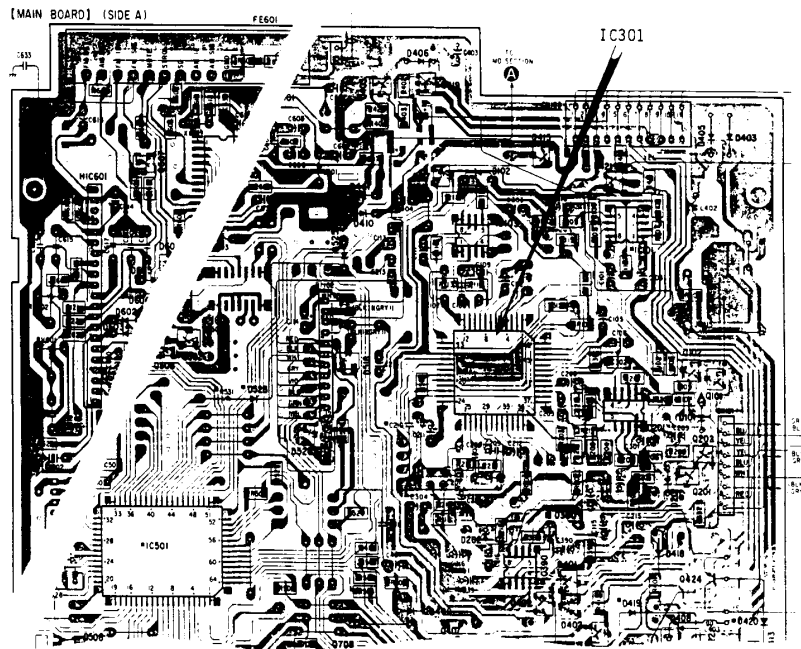
Symptom:
(**) IC301 was mistakenly installed 90 degrees out of position.
The factory has been made aware of this, and has corrected the problem.

Solution: Please check all PCBs ordered from stock to confirm proper positioning of IC301 as shown below:
