Car Stereo Service Bulletin

Model: CDX-5070/5270/5470

No. 370

Subject: Eliminating Static Noise When Using Extension Flex Cable.

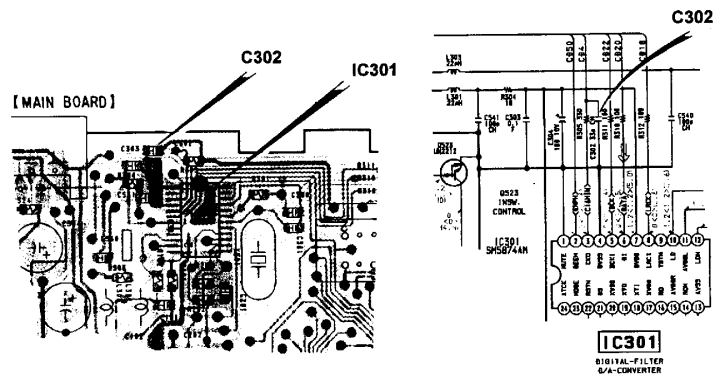
When using the extension flex cable (part number J-2502-011-1) for troubleshooting the CD section, static noise may be heard from the speakers.

Solution: Temporarily remove C-302 on the Main board. Replace C-302 when troubleshooting is finished.
