Car Stereo Service Bulletin

Model: XR-6450 No. **389**

Subject: Display Button Does Not Work. Date: December 14, 1995

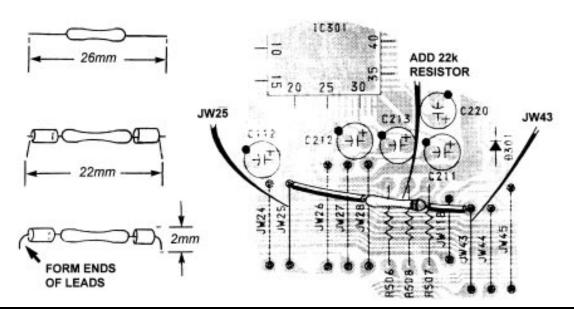
Preparing the resistor:

- 1- Cut the leads so that the overall length is 26mm.
- 2- Insulate the leads as shown.
- 3- Form the ends of the leads as shown.

Solution: If the customer complains of this problem add a 22K ohm resistor between JW25 and JW43 on the main board as shown below.
