Service Bulletin Car Stereo

Model: CDX-91

No. 402

Subject: RESET INDICATED OR ONE DISC LEFT IN MECHANISM.

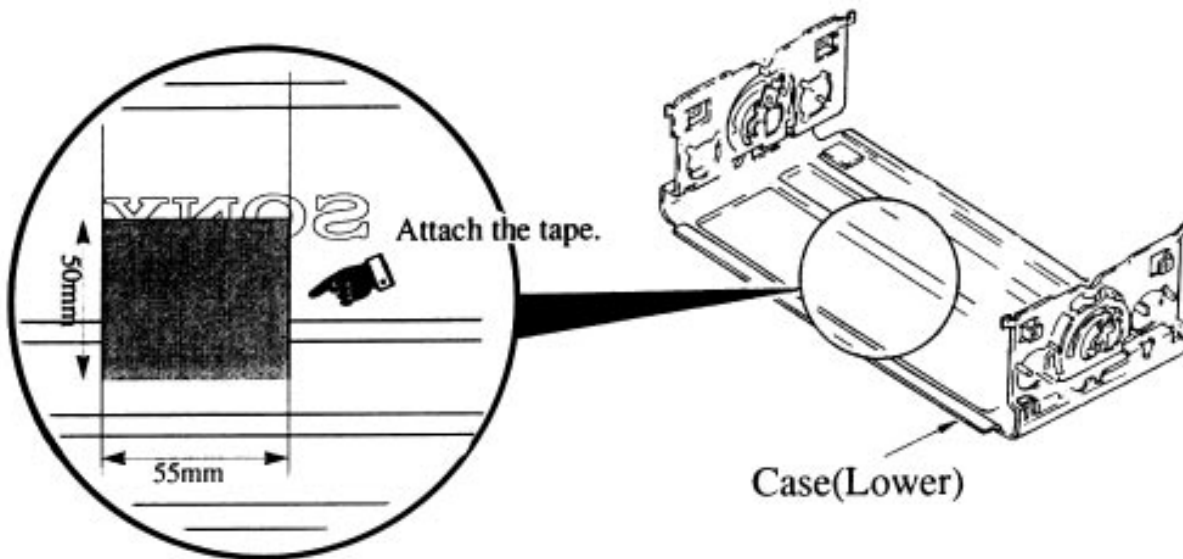
The unit may reset or one CD may be left in the mechanism.

Apply a piece of filament tape to the Case (Lower). This will protect the Case (Lower) and Flexible board from touching each other.
