**Car Stereo  
Service Bulletin**

**Model:** DTX-10

**No.** 201

**Subject:** Service Manual Correction;  
Schematic Diagram, Power Board

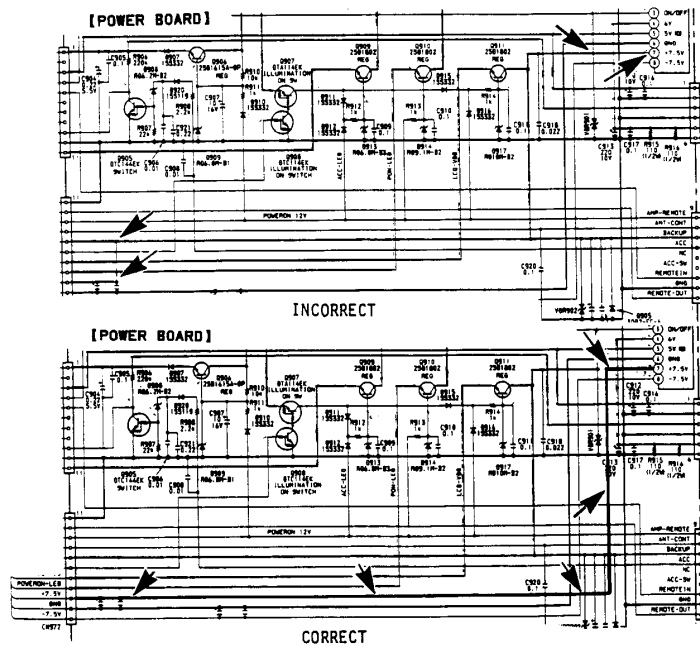
**Symptom:**  
(\*\*) The 7.5 volt supply line is drawn incorrectly on the schematic.

**Solution:** Please make the following correction on Page 46 of your Service Manual:
