Car Stereo Service Bulletin

Model: CDX-7560/7580

No. 210

Subject: Service Manual Correction

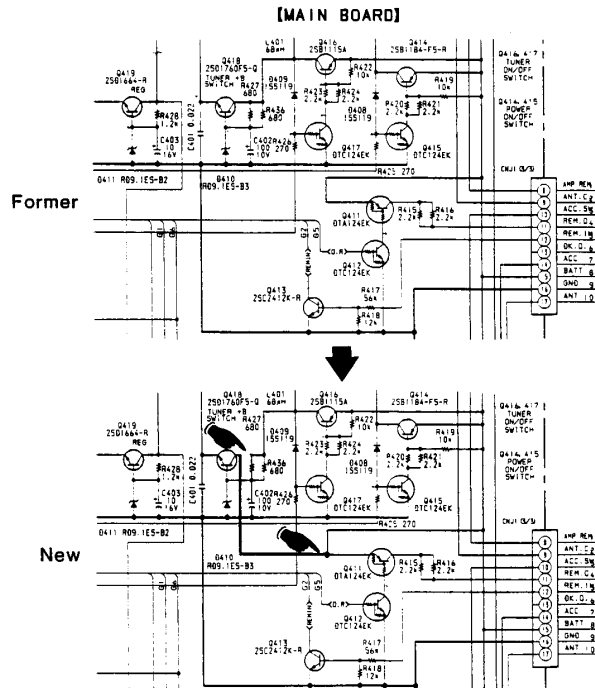
According to the schematic diagram in the Service Manual, the collector of Q418 is connected to the collectors of Q416. This is incorrect.

The collector of Q418 is directly linked with the BATT line, pin 15 of connector CNJ1.
