**Car Stereo  
Service Bulletin**

**Model:** CDX-A15RF/A30RF; XA-7A

**No. 231**

**Subject:** No Audio From Tuner And/Or CD Changer

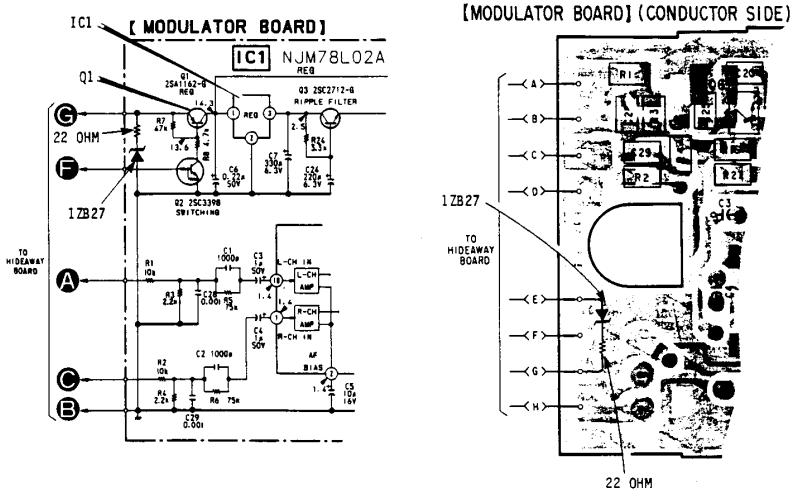
**Symptom:**  
(51) There is no audio from the tuner and/or CD changer.

- Solution:**
1. Repair the unit by replacing Q-1 and/or IC-1 on the modulator board as required.
  2. Prevent re-occurrence of the problem by adding the following parts to the modulator board:

DESCRIPTION	PART NUMBER
ZENER DIODE, 1ZB27	8-719-027-42
RESISTOR, 22Ω 1/4W	1-246-433-15
