Car Stereo Service Bulletin

Model: XR-210A

No. 251

Subject: Part Number Information: Tape Guide; Head Plate Assembly

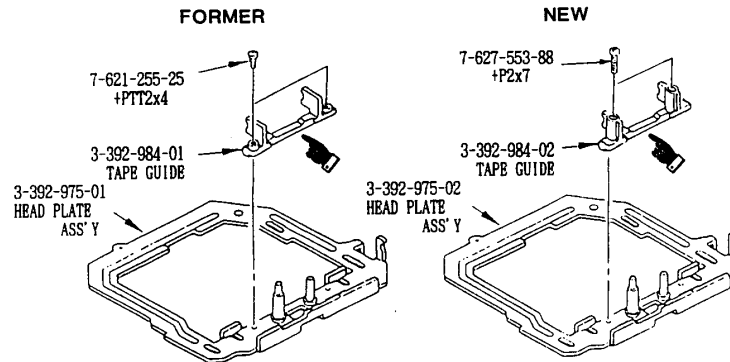
Two (2) different versions of tape guides and head plate assemblies were used in production, but there is no compatibility between each version.

Compare the tape guide and head plate assembly (in the unit being repaired) to the illustration below. Order the parts which correspond to those found in the unit being repaired.
