**Car Stereo  
Service Bulletin**

**Model:** CDX-U8000

**No. 260**

**Subject:** Does Not Retain Last Volume Setting

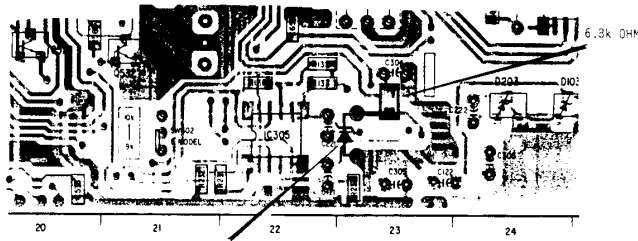
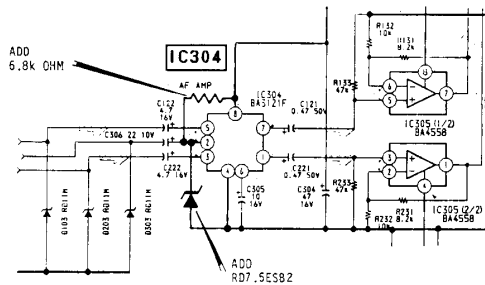
MAIN BOARD  
(CONDUCTOR SIDE)

When the unit is turned on, it may not operate at the same volume level it was operating at when it was turned off. Pressing the VOLUME + or VOLUME - button once will restore the volume level.

Add the following components to the Walkman Input Amplifier Circuit:

DESCRIPTION	PART NUMBER
DIODE, ZENER RD7.5ESB2	8-719-110-03
RESISTOR, METAL CHIP 6.8K	1-216-069-00
