**Car Stereo
Service Bulletin**

Model: XR-U550/U660

No.285

Subject: Antenna Remote Line Does Not Function

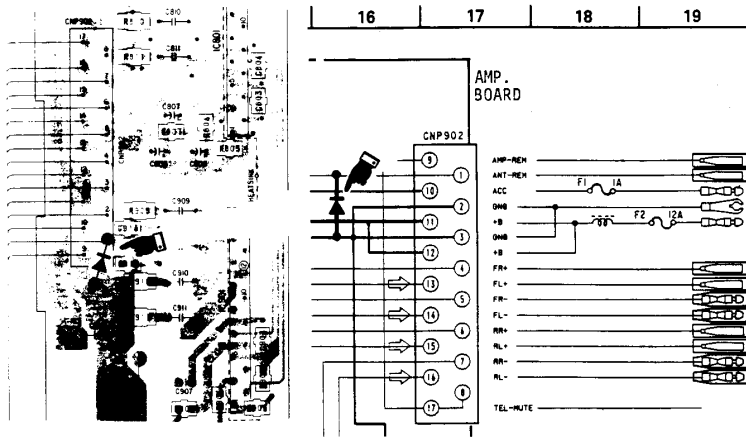
(22) The Antenna Remote line does not function because Q 522 is damaged.

Solution: Replace Q 522, and prevent it from becoming damaged again by adding an 11ES2 diode between the ANTENNA REMOTE line and ground on the AMP board.

REF	DESCRIPTION	PART NUMBER
Q 522	TRANSISTOR, 2SB1184-F5R	8-729-922-47
-	DIODE, 11ES2	8-719-200-82
