Car Stereo Service Bulletin

Model: XR-U220/U330

Subject: Antenna Remote Line Does Not Function

Date: May 21, 1993

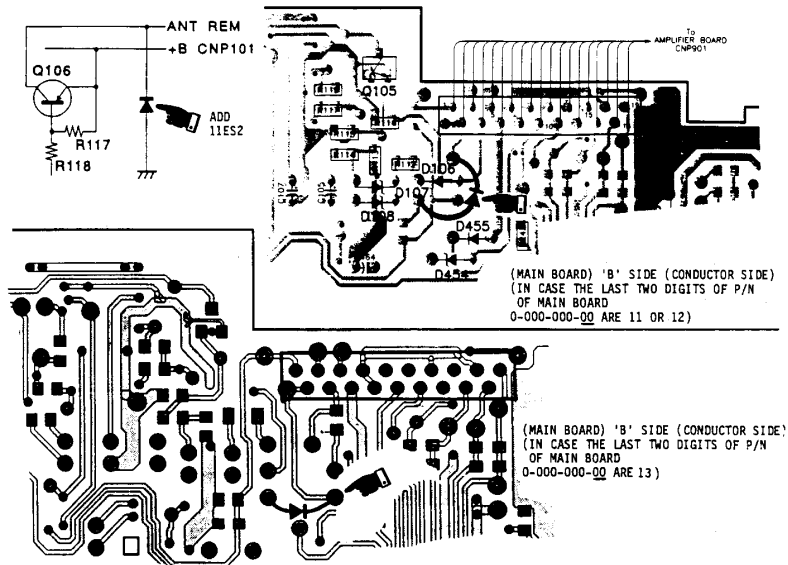
(22) The Antenna Remote line does not function because Q 106 is damaged.

Solution: Replace Q 106, and prevent it from becoming damaged again by adding an 11ES2 diode between its collector and ground.

REF	DESCRIPTION	PART NUMBER
Q 106	TRANSISTOR, 2SB1202FAST	8-729-822-84
	DIODE, 11ES2	8-719-200-82
