# Car Stereo Service Bulletin

**Model:** XR-U550

**No. 305**

**Subject:** CAUTION ALARM is not easily audible.

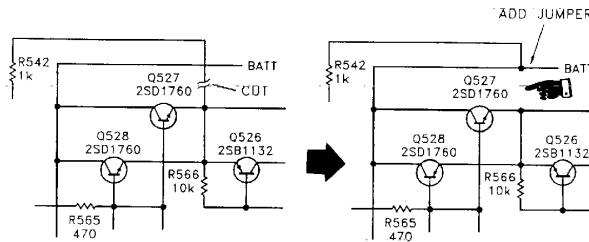
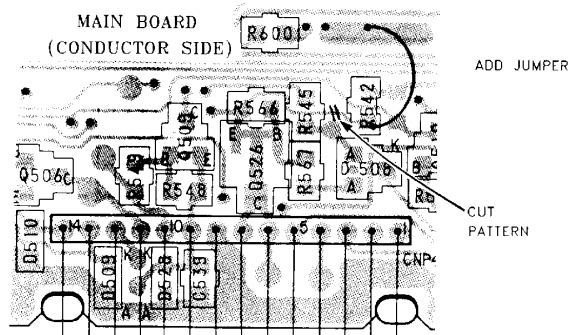
- 1- Cut the pattern between R542 and the emitter of Q527.
- 2- Add a jumper wire between R542 and the BATT line as shown below.

If the customer complains of this, make the following circuit changes to increase the volume.
