Car Stereo Service Bulletin

Model: CDX-900

No. 326

Subject: No Display/No Backlighting.

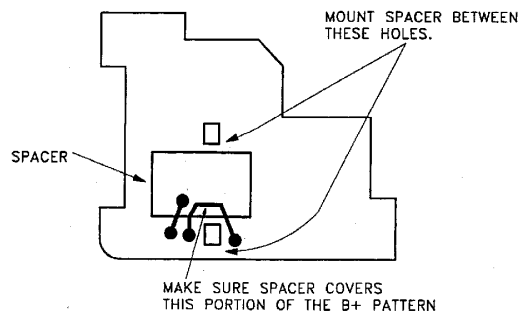
RESET BOARD

The unit does not have any display and/or backlighting.

2- Install a spacer on the B side of the Reset board as shown below. The spacer prevents the B+ pattern from shorting to the metal chassis.

REF	DESCRIPTION	PART NUMBER
-	SPACER	3-892-163-11
