Hi-Fi Products  
Service Bulletin

**Model:** SRS-55

**No.** 47

**Subject:** Hum Is Heard

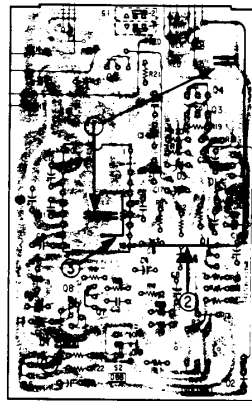
Hum is heard due to a ground loop in the PCB layout.

**Solution:** Please cut the traces and jumpers as shown. A resistor must be added between pins 5 and 10 after the trace under the IC is cut.

Designation	Description	Part Number
R26	2.2Ω	1-249-385-11
