Hi-Fi Products
Service Bulletin

Model: STR-GX5ESI I

No. 124

Subject: Static Noise Heard Through
The Speakers

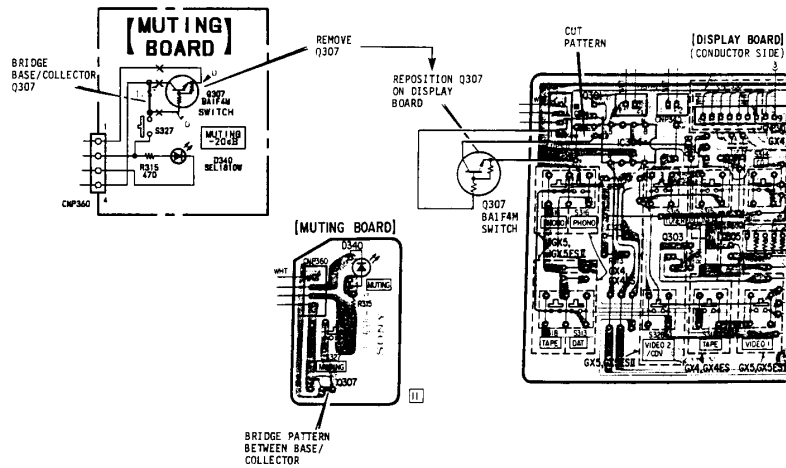
Symptom:
(54)

Noise is generated with the volume knob in the center position.

Solution: Move muting transistor from muting board to display board. This eliminates the connecting cables, and eliminates the noise, as the noise is radiated by the display board and picked up by the cables.

- o Muting Board
 - Remove Muting Transistor Q307
 - Bridge the Base and the Collector.
- o Display board
 - Cut the pattern directly behind Pin 4 of Connector CNP301
 - Install Muting Transistor Q307 on the Conductor side as shown.
