Hi-Fi Products
Service Bulletin

Model: D-2, D-11

No. 210

Subject: Prevention of Flex Cable Damage

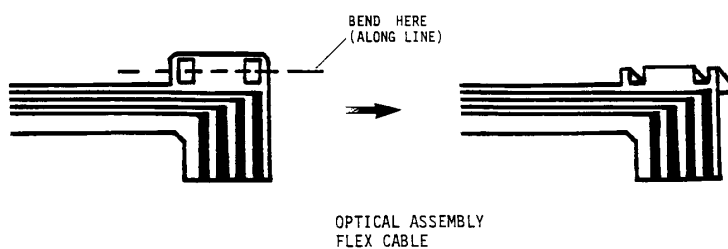
Symptom:
(**) Cracking of the printed wiring portion of the optical assembly flex cable can be prevented by performing the following procedure.

Solution: Bend the flex cable along the dotted line as shown:

This procedure should be performed on every D-2 and D-11 that is being repaired, regardless of the reason.
