Hi-Fi Products
Service Bulletin

Model: TC-H3600

No. 224R1

Subject: Unit Contains Fuse Links On Power Board Which
Are Not Referenced in the Service Manual.

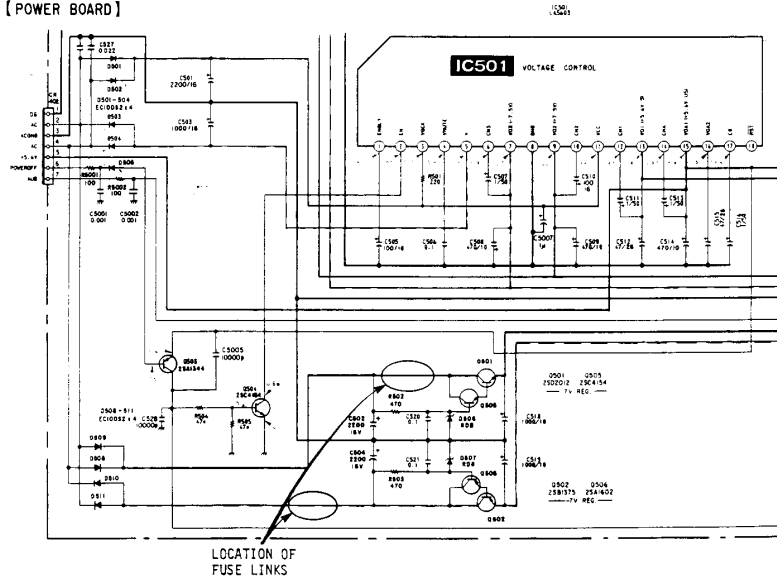
[POWER BOARD]

The unit has (2) 2.5A fuse links, the first connected in series with the collector of Q501 and the bridge rectifier and the second connected in series with the collector of Q502 and the bridge rectifier. The Service Manual does not reference these parts.

Solution: The correct part number and schematic location of the fuse link described above are shown below:

DESCRIPTION	PART NUMBER
FUSE, MICRO (2.5A, 125V)	1-532-780-21
