Hi-Fi Products
Service Bulletin

Model: D-303

No. 237

Subject: Unit Will Not Play

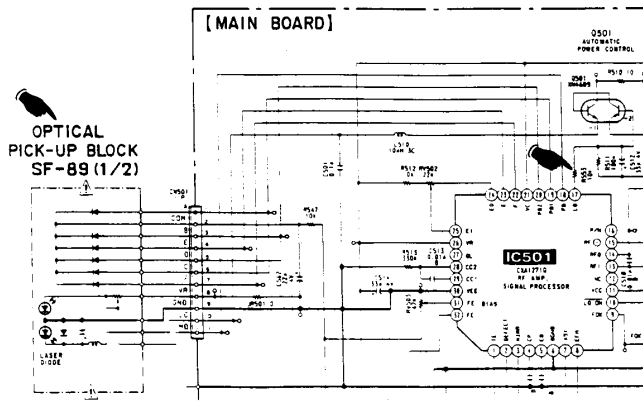
3. After performing Step 2., use green or orange magic marker and mark IC501 as shown.

- Solution:**
1. Check the current into the laser diode as per instructions on page 4 of the Service Manual:
 2. If the current measured is greater than the allowed range, perform the following:
 - a. Change the optical pick-up block.
 - b. Change R553 from 10K ohms to 33K ohms.

4. For units with Serial Numbers 24000 and more, the modification has been performed.
To verify, check:

- a. Label on box as shown:

- b. Green or orange mark on IC501
