Hi-Fi Products
Service Bulletin

Model: TA-AX311/AV411

No. 253

Subject: Display Failure

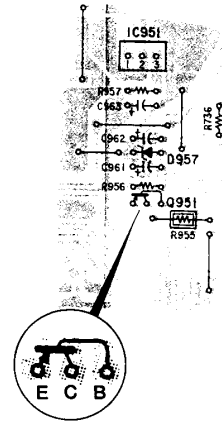
NOTE: Be sure to follow the correct orientation of the new component when installing.

Solution: Check R955 & D957 and replace with parts listed in the Service Manual if necessary. Replace Q951 with the part number shown in the chart below:
