Hi-Fi Products
Service Bulletin

Model: CDP-67ES/C615

No. 260

Subject: Right Hand Side Segments of Display Light, Even When
The Power Is Off **Date:** March 20, 1992

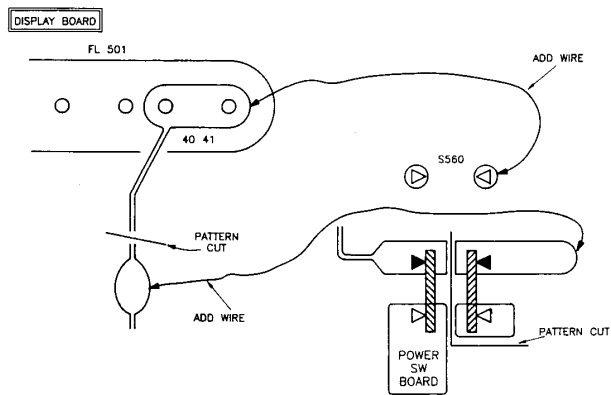
Symptom:
(13) Right hand side segments of the display light, even when the power is off.

- Solution:** Perform the following modification:
1. Cut pattern off FL501 / pin 40 and 41 in the Display Board as shown.
 2. Cut pattern off power switch S560 in the power SW Board as shown.
 3. Add wire from power switch S560 to FL501 / Pin 41 as shown.
 4. Add wire from power switch S560 to pattern as shown.
