Hi-Fi Products  
**Service Bulletin**

**Model:** TA-AV411

**No. 264**

**Subject:** Unit In Protection

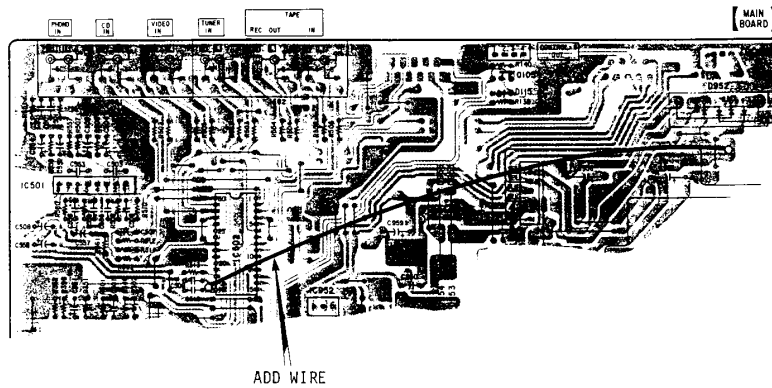
**Symptom:**  
(51) Unit in protection after tightening all ground screws.

**Solution:** The screw which secures J501 to the rear panel (CD and PHONO input jack) breaks the solder joint between J501 and the PCB when tightened. Add a ground wire as shown in the diagram below.
