Hi-Fi Products
Service Bulletin

Model: STR-AV23/270X/370X/570X

No. 281

Subject: Preventing Damage To Display Board When Changing CPU IC301.

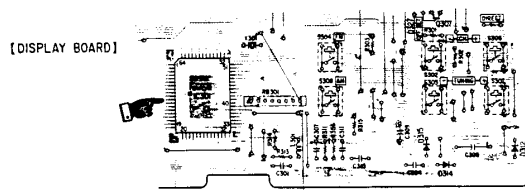
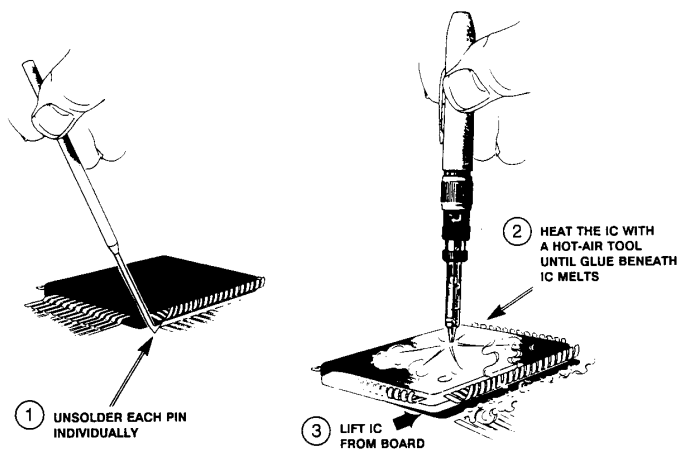
The glue which secures the CPU IC301 to the display board may make it difficult to remove without damaging the board.

Unsolder each pin of the IC individually, using a soldering iron and a tool such as a dental pick. Then heat the IC with a hot air tool, such as the Weller Model WST2 PyroPen, until the glue melts, allowing the IC to be easily removed.
