Hi-Fi Products
Service Bulletin

Model: STR-AV720

No. 292

Subject: Replacement Part For Main Board Is Different
From Original

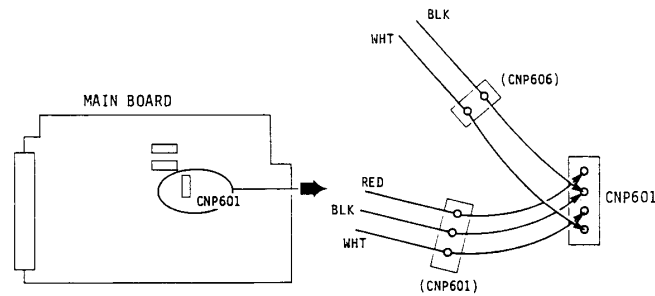
The replacement part for the main board has one single 4-pin connector for CNP601, while the original main board has one (3) Pin and one (2) Pin Connector for CNP602.

Cut the female mate plugs which formerly connected separately to the (2) and (3) Pin Connectors for CNP601. Strip the ends of each of the five wires back approximately 1/16 inch and solder directly to the (4) Pin Connector for CNP601. See the diagram below for details on making proper connections.
