Hi-Fi Products
Service Bulletin

Model: STR-D1090

No. 295

Subject: No Display and No Sound

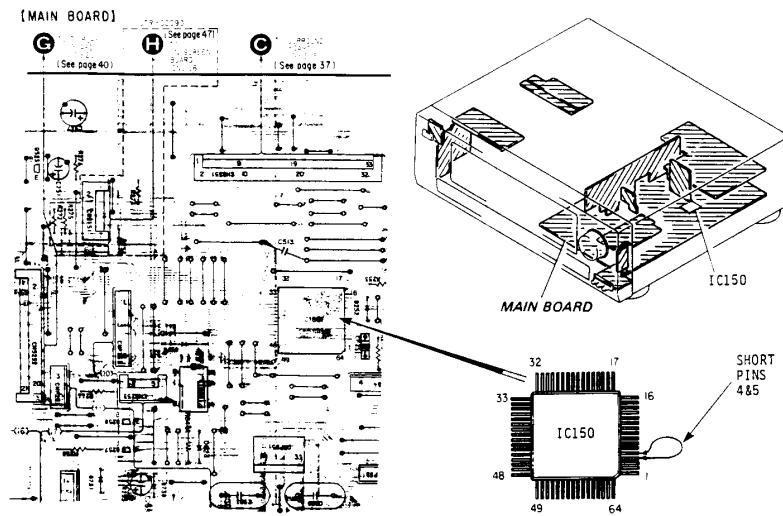
When operating the unit, there is no display (other than the cursor mode LED) and the sound suddenly cuts out. The set can be reset by turning the power button off and then on.

Form a solder bridge between Pins 4 and 5 on system control IC150 on the main board. Pin 5 on IC150 is floating (no connection) and is easily influenced by noise. As a result, system control IC150 locks up.
