Hi-Fi Products  
**Service Bulletin**

**Model:** CDP-C225 / C325 / C425

**No. 319**

**Subject:** Portions Of The Display Are Constantly Lit

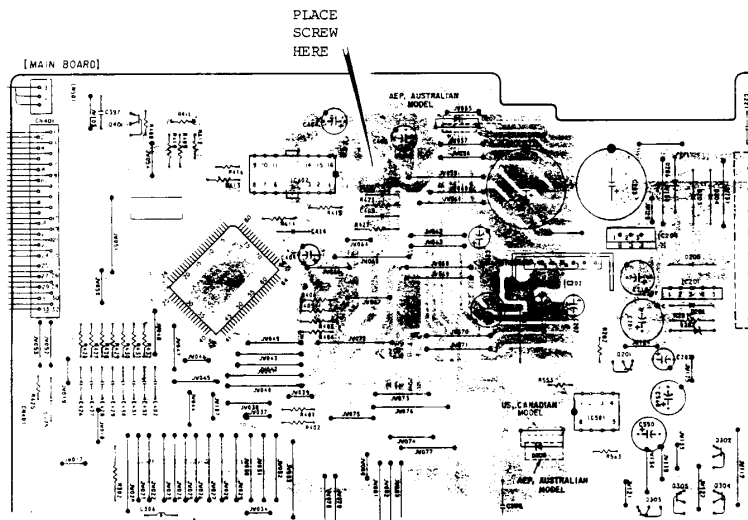
Portions of the display are constantly lit when the unit is powered on. The Main PC board becomes loose from the finger snap hold down which holds it to the chassis. This results in the Main PC board shorting to the bottom metal case which causes problems with the display.

Snap the Main PC board back onto the finger snap hold down and add a screw (type shown in the chart below) at the location shown in the drawing below.

DESCRIPTION	PART NUMBER
SCREW TAP +BV 3.0X8.0 BLK	7-685-646-79
