**SONY** ..... Hi-Fi Products ..  
**Service Bulletin**

**Model:** D-113CR

**No. 364**

**Subject:** defective display (main board cracked)

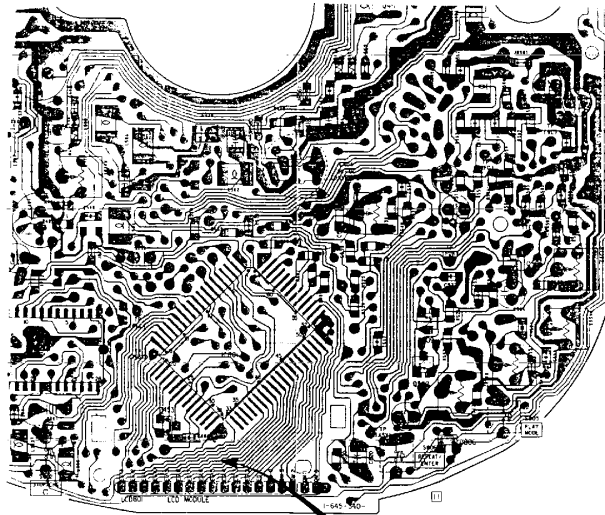
(13) Defective Display caused By A Crack In The Main Board Between IC801 And LCD801.

ADD CUSHION  
IN THIS AREA

Add a cushion to the board's area where the crack occurred to prevent it from breaking again.

REF	DESCRIPTION	PART NUMBER
-	CUSHION	3-533-310-11
