Hi-Fi Products
Service Bulletin

Model: HCD-C70
HCD-C90

No. 392

Subject: No CD operation when connected to the PFJ-1
jig.

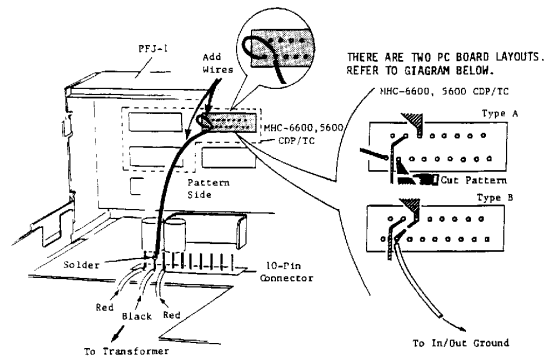
CD operation is unstable or inoperable when connected to the PFJ-1 power supply.

Solution: Revise the wiring of the PFJ-1 as outlined below.
