Hi-Fi Products
Service Bulletin

Model: D-802K

No. 395

Subject: Battery Wire Shorted Or Mis-connected

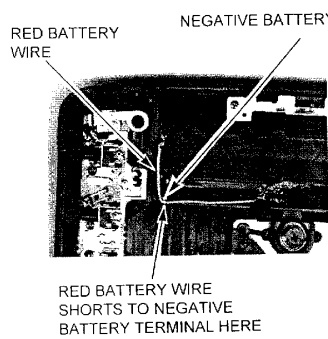
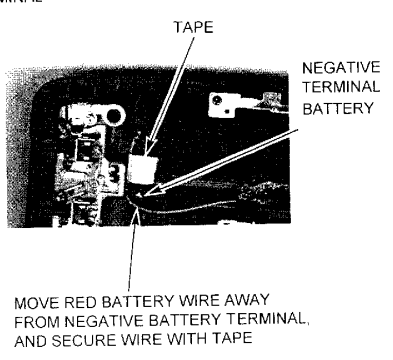
On some units the positive (red) wire from the battery compartment may be connected to the wrong place on the Main board. On some units the positive (red) wire from the battery compartment may be shorted by the negative battery terminal.

Take corrective action if either of these conditions are encountered, i.e. move the red wire to the correct connection point on the Main board, and/or move the red wire away from the negative terminal and secure it with tape.
