Hi-Fi Products Service Bulletin

Model: TC-WR80ES/WR820A/WR87ES/WR775/
WR590/WR535/WR545/WR635S/
WR670/WR690/WR701ES/WR720A/
WR720/WR801ES/WR790 **No. 410**

Subject: New Spring for Replacement Head Base Assembly **Date:** September 7, 1994

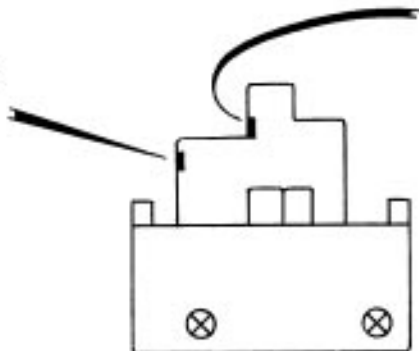
HEAD BASE ASSEMBLY

There are two types of head base assemblies and head base springs. Use the new type of head base spring (listed below) when the new type head base assembly is used

FORMER

FOR THE FORMER TYPE
ONE END OF THE HEAD
BASE SPRING IS HOOKED
ON TO THE SHADED
PORTION AS SHOWN

NEW

FOR THE NEW TYPE,
ONE END OF THE HEAD
BASE SPRING IS HOOKED
ON TO THE SHADED
PORTION AS SHOWN

FORMER		NEW	
DESCRIPTION	PART NUMBER	DESCRIPTION	PART NUMBER
HEAD BASE SPRING	3-359-455-01	HEAD BASE SPRING	3-907-362-01
