Hi-Fi Products Service Bulletin

Model: D-335, TCD-D7

No. 419

Subject: No Digital Recording

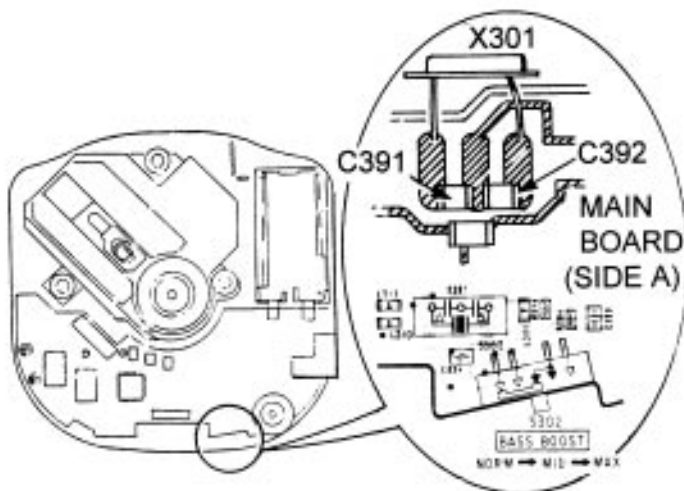
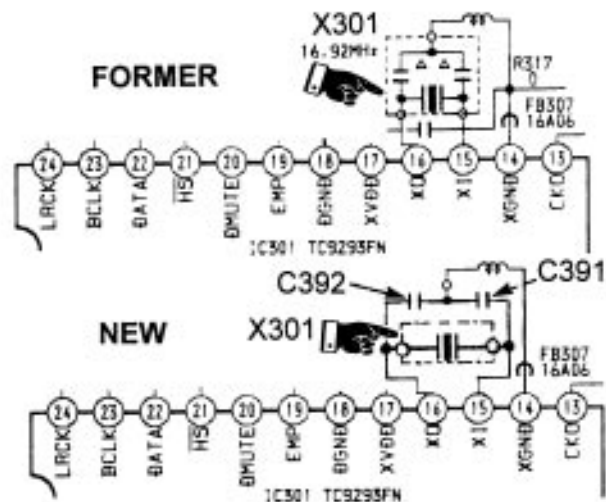
Digital recording is impossible when connecting D-335 to TCD-D7 using an optical connection cable.

Apply the following changes on the Main Board of D-335.

1. Replace the Ceramic Oscillator X301 with a Crystal oscillator.
2. Add 2 capacitors.

REF	FORMER		NEW	
	DESCRIPTION	PART NUMBER	DESCRIPTION	PART NUMBER
X301	CERAMIC OSCILLATOR	1-760-404-11	CRYSTAL OSCILLATOR	1-567-908-11
C391/ C392	-	-	15PF/50V CERAMIC CHIP CAPACITORS	1-162-917-11
