Hi-Fi Products Service Bulletin

Model: D-137CR No. 438

Subject: No Sound Date: May 15, 1995

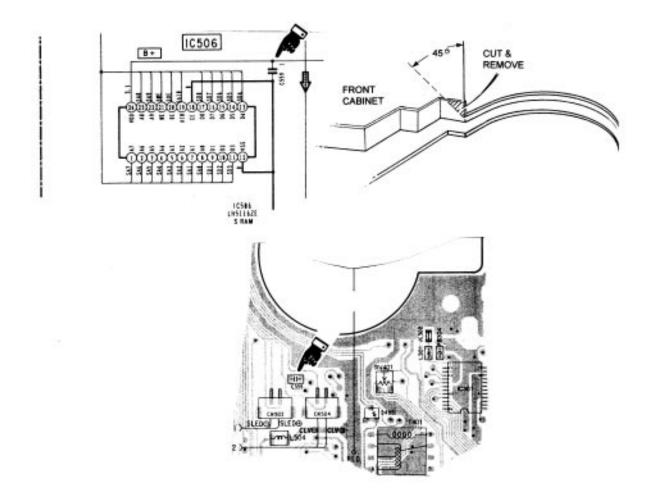
(154) No Sound is heard, only noise.

Solution: Cracks in the solder of C559 are caused by stress on the board from the front

cabinet.

• Resolder C559 on the main Board. (section F-8 on the physical diagram)

• Cut the Front cabinet, as shown in the diagram below to help relieve the stress.
