Hi-Fi Products Service Bulletin

Model: HCD-H305, HCD-H405, HCD-H605, MHC-C305, MHC-C405, MHC-C605, MHC-C33, MHC-C55 **No. 459R1**

Subject: TRAY JAMS **Date:** February 15, 1996

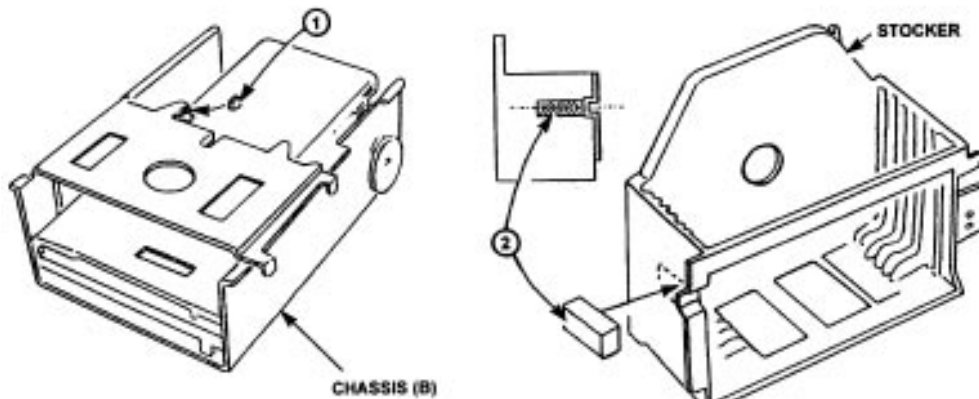
Symptom:
(161) The tray may jam due to the tray ass'y and stocker(Ref # 332) being out of position. This causes the sub tray to be released from the hook.

Solution: Attach a spacer and a rubber cushion in order to fasten the stocker.

Ref.	Description	Part No.
1	SPACER	4-977-341-01
2	RUBBER CUSHION	4-973-608-01
