Model: CDP-C265, CDP-C365, CDP-C445, CDP-C545 **No. 480**

Subject: Disc Tray Won't Open **Date:** April 29, 1996

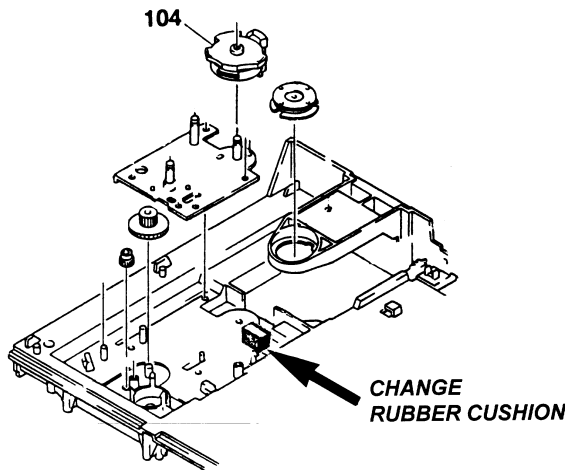
Symptom:
(161) The disc tray may be jammed and will not open. The U/D gear (#104) may rotate clockwise during transportation causing the mechanism to jam.

Solution: If a unit comes in for service for any reason, replace the right side (facing the unit) rubber cushion with a new improved type. Please see the diagram below for location of the cushion.

Description	Part Number
Rubber Cushion	4-981-731-11
