Service Bulletin Hi-Fi Products

Model: CDP-CA8ES, CDP-CA9ES

No. 489R1

Subject: Unstable Audio

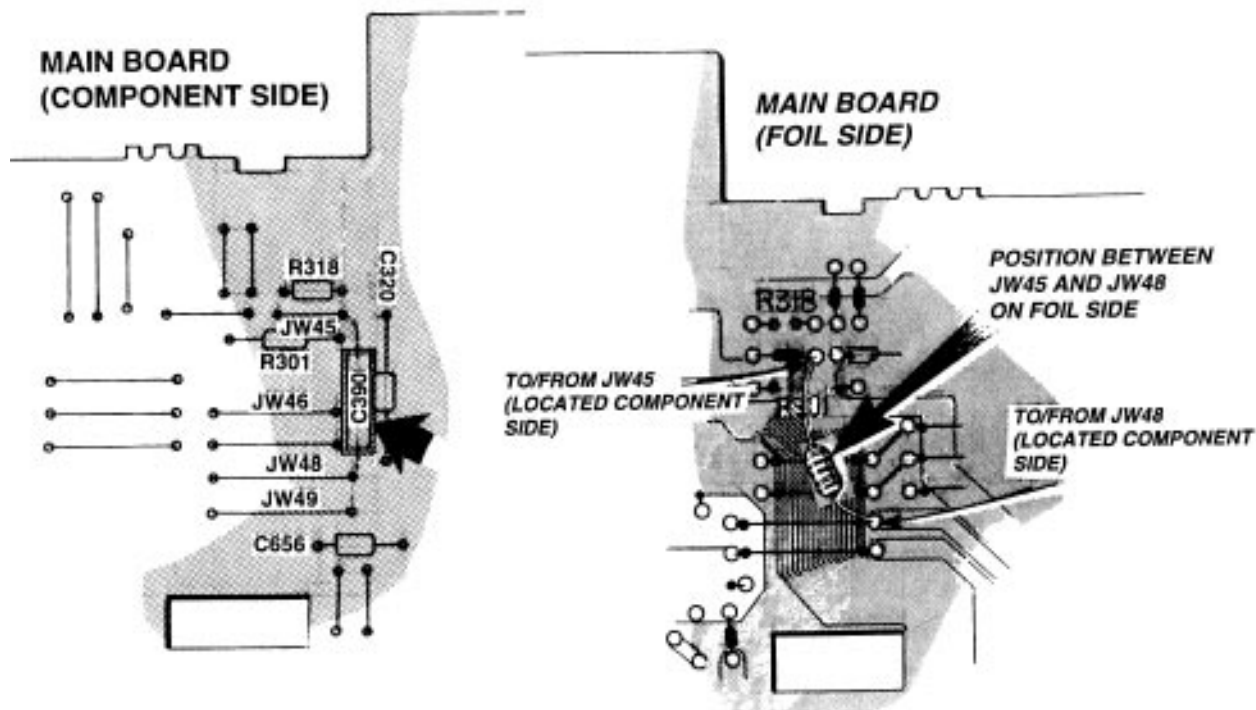
If the part number of the Main board is 1-655-603-13, the capacitor is located between JW45 and JW48 and mounted on the foil side of the board. The capacitor is accessible from the bottom of the unit.

If the part number of the Main board is 1-655-603-14, the 470pF capacitor is mounted on the component side of the board and is labeled C390. The main board should be removed to desolder the 470pF capacitor.

Remove the 470pF capacitor located on the main PC board. There are two different main boards used in these models.
