Service Bulletin Hi Fi Products

Model: D-335

No. 512

Subject: Abnormal LCD Display and / or No Key Input

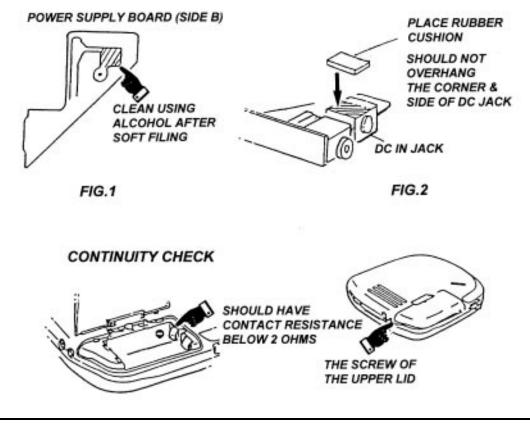
(**) Abnormal LCD Display and / or No Key Input accepted Applicable Serial Numbers (100,001 ~ 251,510)

Solution: 1. File the pattern of the power supply and clean it with alcohol (See fig 1.)

2. Place Rubber cushion on top of the DC in Jack (Fig. 2)

Confirm continuity between the screw in the upper lid and the Negative (-) terminal of the Battery
