Service Bulletin Hi-Fi Products

Model: HCD-H100 No. **523R1**

Subject: The Unit Does Not Detect a Disc Date: April 14, 1997

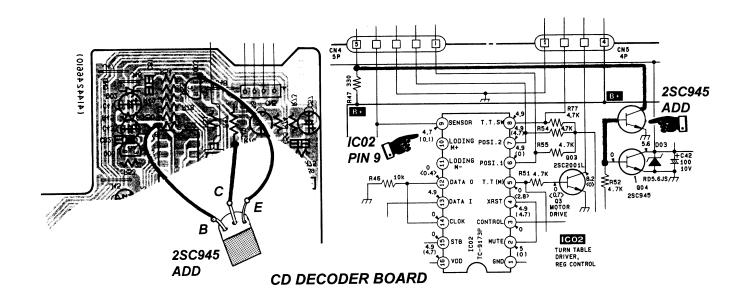
(62) The unit does not detect a CD in the disc tray.

Solution: Replace I/R LED D04 (8-719-058-76) and add the following transistor in circuit to the CD Decoder Board as outlined below.

REF	DESCRIPTION	PART NUMBER
N/A	2SC945-P	8-729-194-57

Check the voltage at IC02 pin 9 on the CD Decoder Board (1/2). With a disc inserted the voltage should be less than 1.2V. When no disc is inserted the voltage should be 3.5V. If these voltages are not within the operating range, replace phototransistor PH01(8-729-036-35).
