Service Bulletin

Model: CDP-CX90ES, CDP-CX270

No. 533

Subject: Digital Noise in Audio

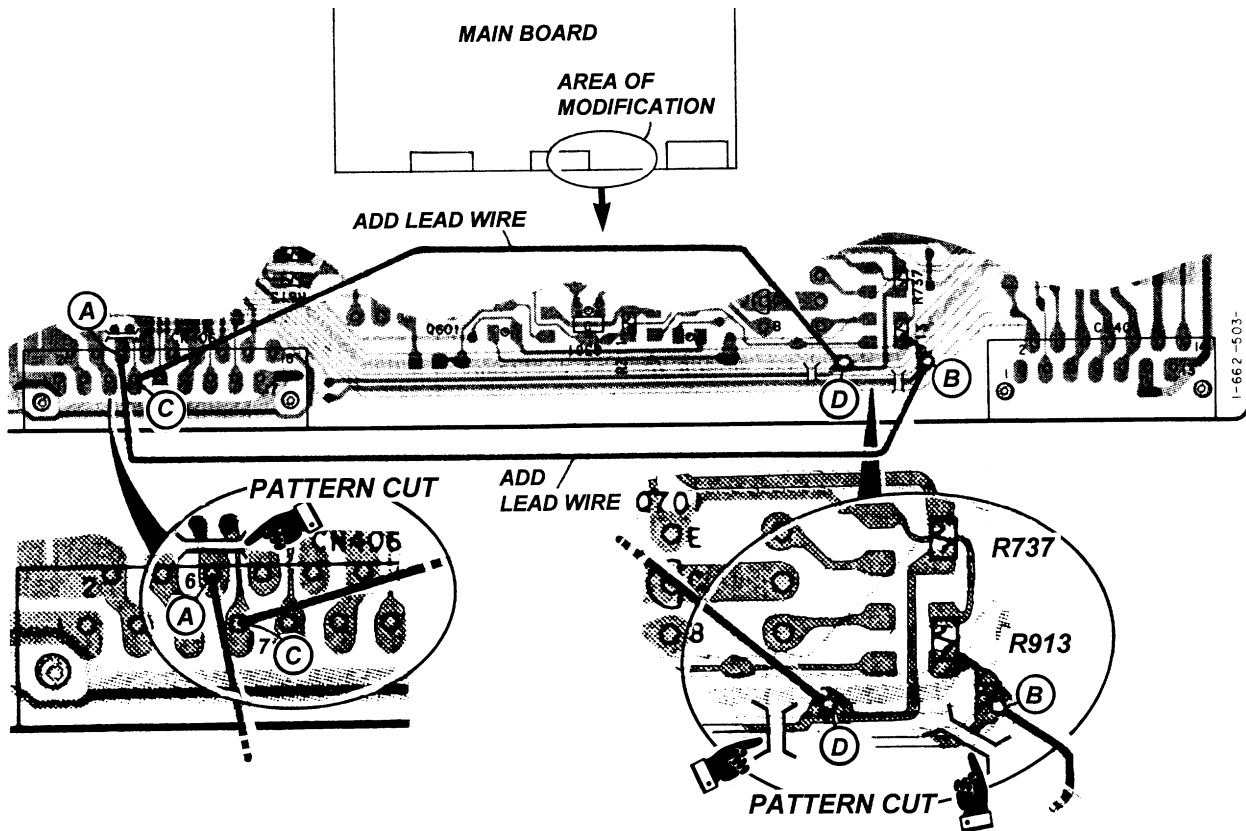
(54) The customer may complain of a "beep" noise on the audio.

- 1.) Using a razor knife, cut the foil patterns outlined below.
- 2.) Connect jumper wire leads from A to B and from C to D (see diagram).
