Model: CPD-15SF2, CPD-17SF2

No. 145

Subject: No picture with Wide Vert. Sync. Pulse

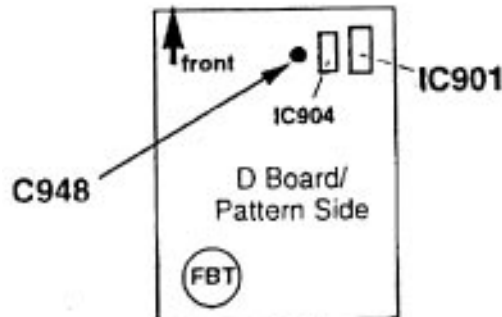
C948 & IC901 LOCATION

If set has no picture when Vert. Sync Input has Wide ($\geq 400 \mu\text{s}$) Vert. Sync. Pulse. Unit may not accept Vert. Sync. and go in Power Save mode.

1. Replace IC901. Refer to illustration shown below.
2. Replace C948 with 0.22 μF part. Refer to illustration shown below.
