**Model:** CPD-200ES**No.** 204**Subject:** Picture Shaking; Faulty C620**Date:** June 15, 1998**Symptom:**  
**(3350)**

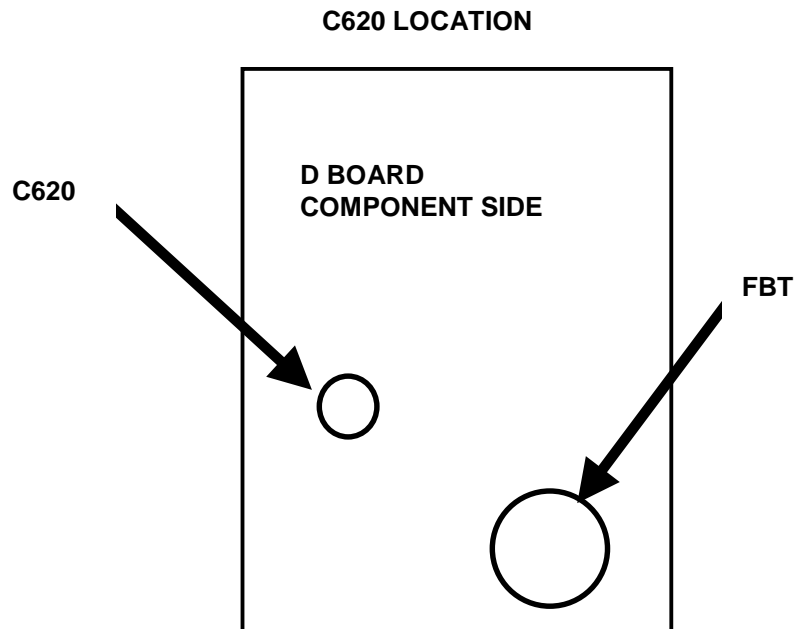
The picture appears to be shaking after the unit has been in use for a period of time. C620, the AC rectifier filter capacitor in the power supply circuits may be faulty.

If the customer complains of this symptom, then please check C620 on the D Board. C620 may appear to be slightly expanded at the top. Replace C620 if necessary.

REF	DESCRIPTION	PART NUMBER
C620	390 $\mu$ F 20% 400V	1-109-984-11

Please refer to illustration below.
