# Computer Monitors Service Bulletin

**Model:** GDM17SE1

**No. 76**

**Subject:** Countermeasure for High Pitch Squeal

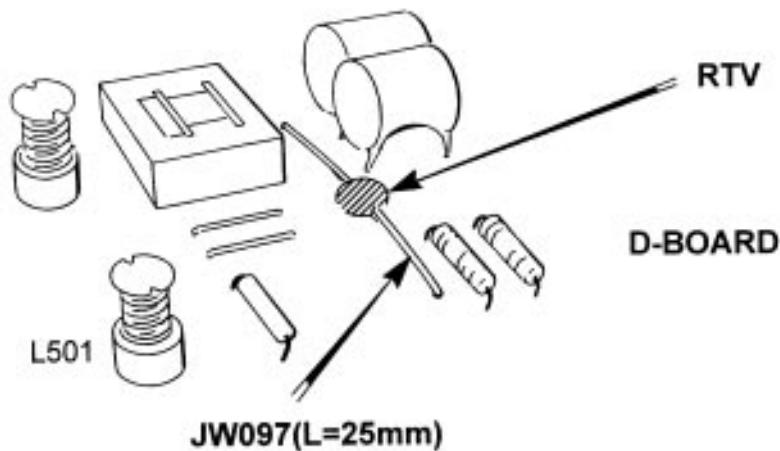
A high frequency squeal is audible when using the MAC 16" Mode

The noise comes from JW097 (jumper wire). JW097 vibrates due to L501 (Horizontal Linearity Coil). To confirm the noise source, touch the center of JW097 using a plastic adjustment tool.

JW097 is located in the middle of the D-Board near L501 and T502.

If the Noise is confirmed, apply RTV in the middle of the jumper wire as illustrated below:
