Computer Monitors Service Bulletin

Model: GDM17SE1, GDM20SE1

No. 86

Subject: D824 Improvement

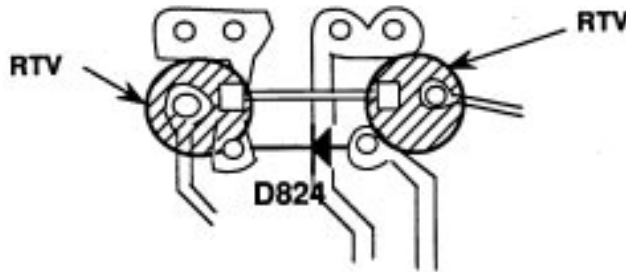
(131) No Picture due to HV shutdown

Solution: Please check D-824 on the D-Board. If shorted, replace as follows:

1. Replace D824 with a 1SS83 type

DESCRIPTION	PART NUMBER
1SS83 DIODE	8-719-901-83

2. Apply RTV to locations illustrated below:
