# Computer Monitors Service Bulletin

**CSI-111**

**Model:** GDM17SE1, GDM20SE1

**Subject:** Deflection Circuit Improvement

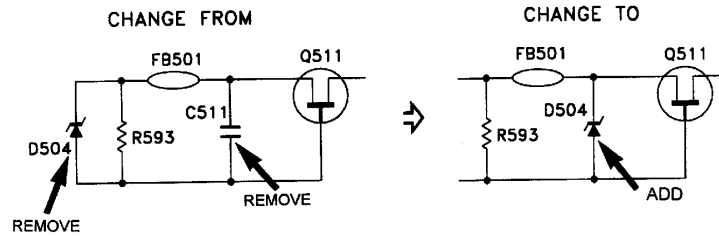
**Symptom:**  
(111)

No operation, Front Panel LEDs are flashing

- 3 Remove C-511.
- 4 Remove D-504 and mount it to the C-511 lands.
