Resecure Door Handle Back Seal

Classification Repair Bulletin **Section/Group** 11 - Closures **Country/Region** All

Year 2012–2015 **Model** Model S **Version** All

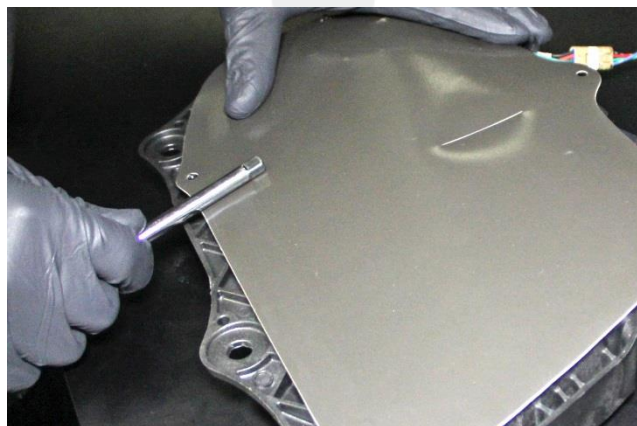
Figure 1

TIP: Roll the side of a small tool socket or similar tool on the back seal while applying firm pressure to ensure proper seating of the butyl seal on the door handle assembly (Figure 1).

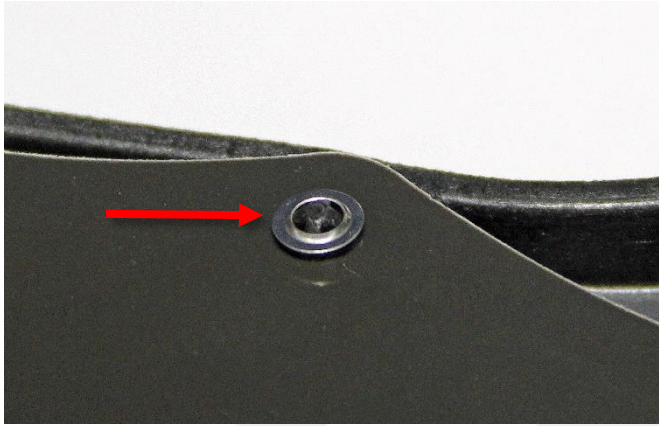
Figure 2

- Put 1 push nut on top of each stud (Figure 2). Use a deep 5 mm socket to press the push nut over the stud (Figure 3). Do not use excessive force to drive the push nut into the stud. Repeat this step for the rest of the studs (total of 4 push nuts/studs per front door handle and 3 push nuts/studs per rear door handle).

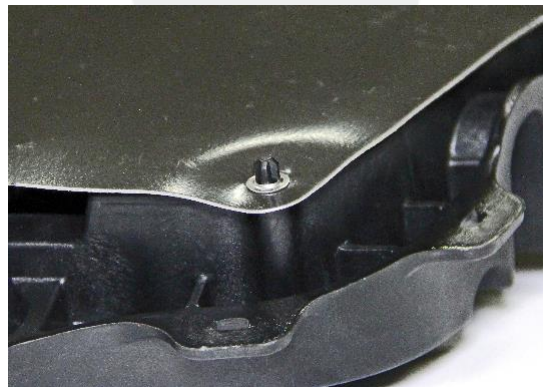
Figure 4

NOTE: Ensure that the push nut is firmly set into the stud without a gap between the back seal and the door handle assembly (Figure 4).

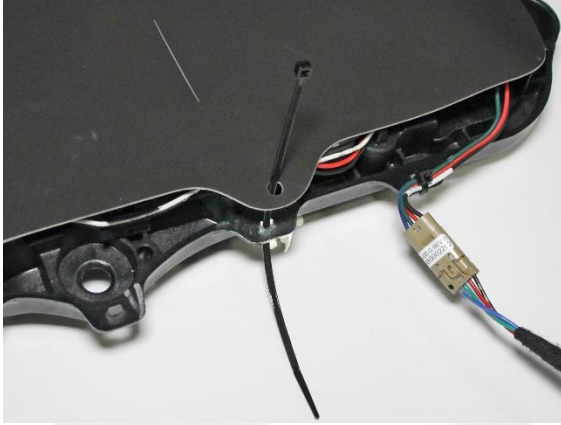
Figure 5 (Front door handle shown)

6. Use a cable tie to secure the back seal to the door handle assembly. Loop the cable tie as shown (Figures 5 and 6).

- ⚠ CAUTION:** To avoid damage to the back seal, do not overtighten the cable tie.
- ⚠ CAUTION:** To avoid damage to the door handle electrical harness, ensure proper routing of wires.

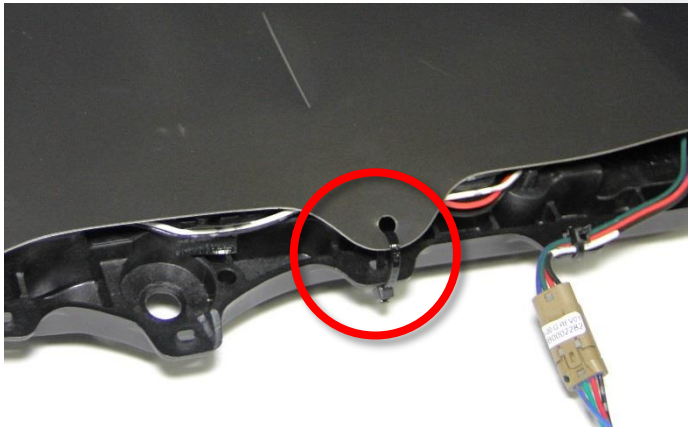
Figure 7 (Front door handle shown)

7. Remove any excess cable tie (Figures 7 and 8).
