# Replace Prototype 12V Fuse Box Bracket

**Classification** Campaign Bulletin    **Section/Group** 17 - Electrical    **Country/Region** United States

**Year** 2014    **Model** Model S    **Version** Dual Motor

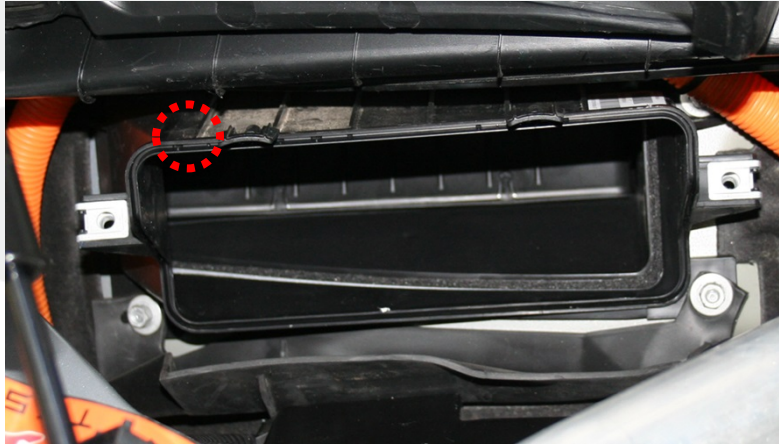
Figure 1

1. Disconnect 12V power (refer to Service Manual procedure 17010200).
2. Remove the pollen filter rear housing:
  - a. Release the 2 barrel clips that secure the HV harness to the bulkhead.
  - b. Loosen the top RH nut that secures the pollen filter rear housing to the bulkhead (torque 6 Nm) (Figure 1).

**NOTE:** It is not necessary to completely remove the nut; the tab on the housing is notched.

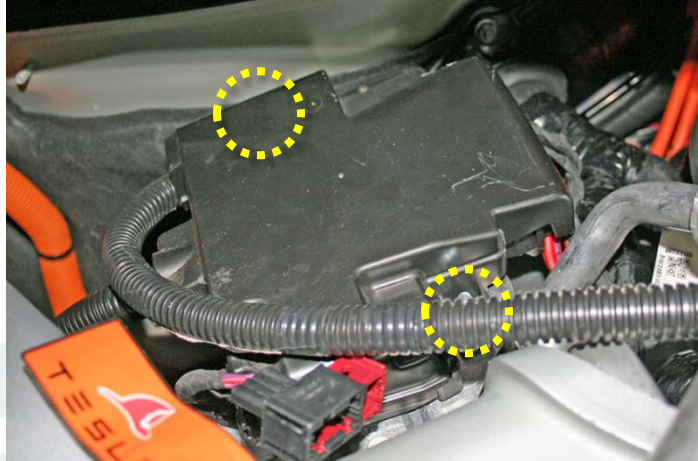
**Figure 3**

3. Remove the 2 bolts that secure the fuse box cover (Figure 3). Remove the fuse box cover.

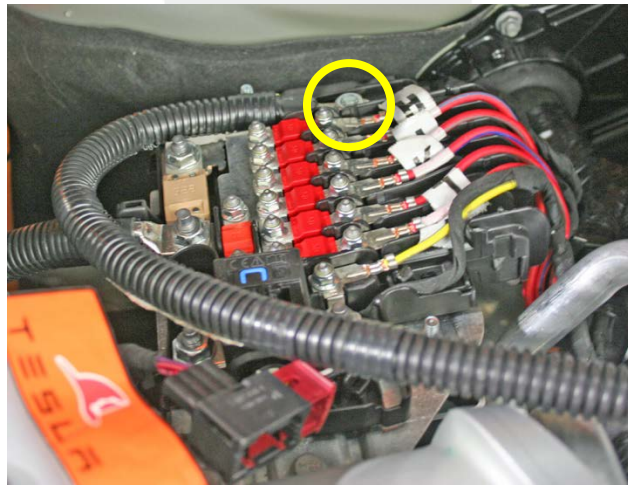
**Figure 4**

4. Remove the nut that secures the battery positive terminal to the rear of the fuse box (Figure 4).

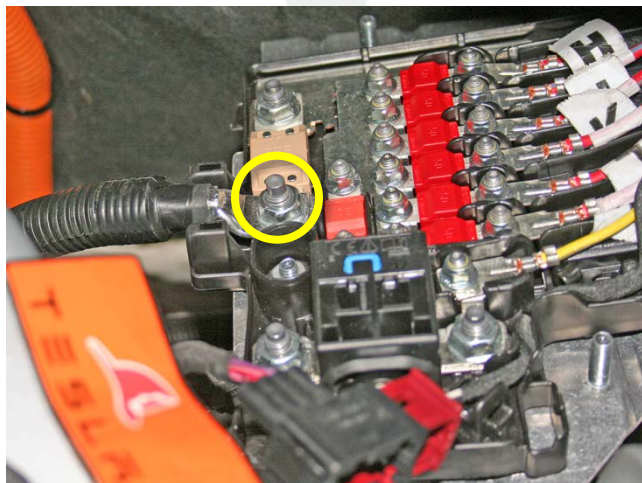
**Figure 5**

5. Remove the nut that secures 12V power supply for the DCDC converter (Figure 5).

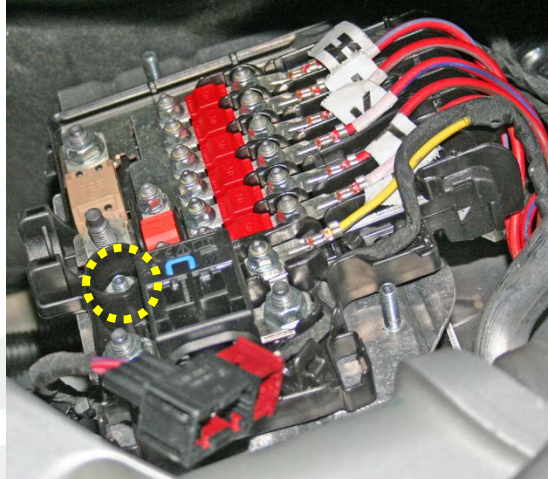
**Figure 6**

6. Remove the nut that secures the fuse box to the bracket (Figure 6).

33. Ensure that the A/C lines do not rub against the upper bracket.
34. Insert the stud into the bottom of the fuse box (Figure 7) and set the fuse box on top of the upper bracket.
35. Reinstall the nut that secures the fuse box to the bracket (torque 6 Nm) (Figure 6).
36. Reinstall the nut that secures 12V power supply for the DCDC converter (torque 12.5 Nm) (Figure 5).
37. Reinstall the nut that secures the battery positive terminal to the rear of the fuse box (torque 12 Nm) (Figure 4).
38. Reinstall the 2 bolts that secure the fuse box cover (torque 3 Nm) (Figure 3).
39. Reinstall the pollen filter rear housing and HVAC intake drain diverter.
40. Connect 12V power (refer to Service Manual procedure 17010200).

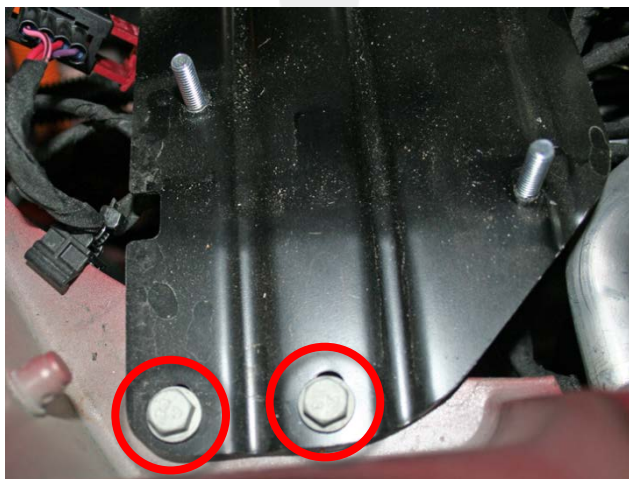
**Figure 8**  
**TESLA**

8. Remove and discard the 2 bolts that secure the front of the fuse box bracket to the shock tower (Figure 8).

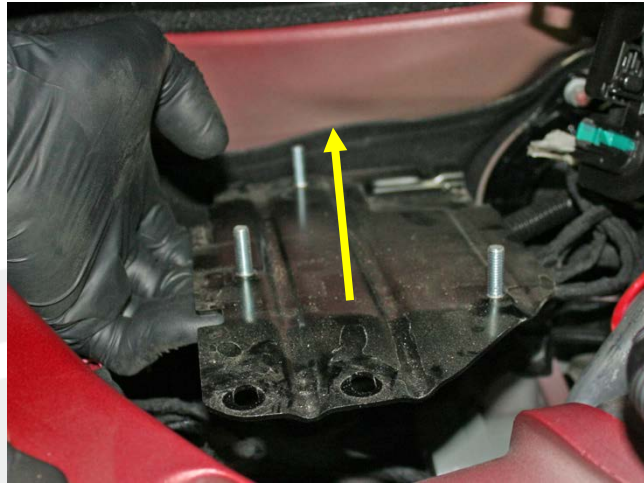
**Figure 9**

9. Bend the front of the bracket towards the bulkhead (Figure 9).

**NOTE:** It is okay to damage the bracket; it will be discarded later in the procedure.

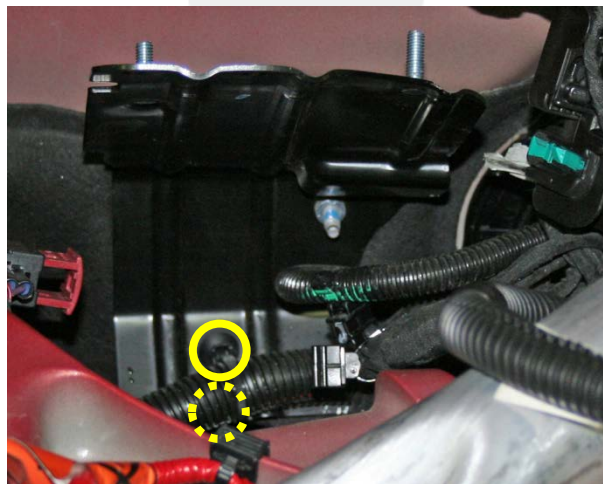
**Figure 10**

10. Remove the 2 fir tree clips that secure the 12V harnesses to the bracket (Figure 10).

**NOTE:** The 12V harnesses can be secured to the bracket in multiple ways. Figure 10 shows one example. Remove the fir tree clips as necessary.

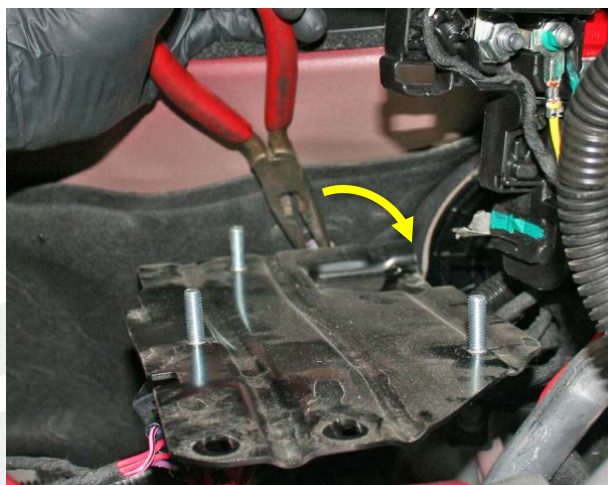
Figure 15

- From behind the bracket, continue rotating the screw clockwise (Figure 15) until it the bracket is free. Remove and discard the bracket.

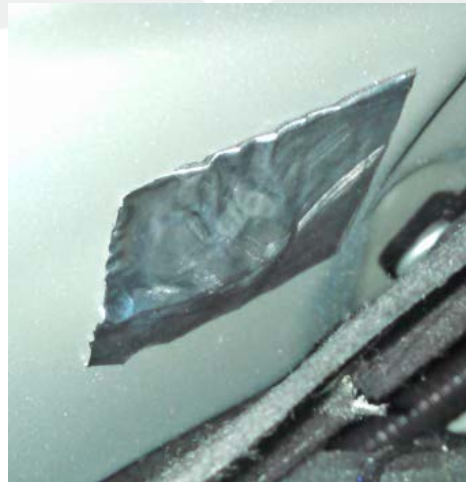
**Figure 17**

22. Apply a butyl foil patch over the hole in the bulkhead (Figure 17).

**NOTE:** Smooth out the entire surface of the butyl patch to ensure that it is fully adhered to the bulkhead and that all of the air bubbles have been removed.

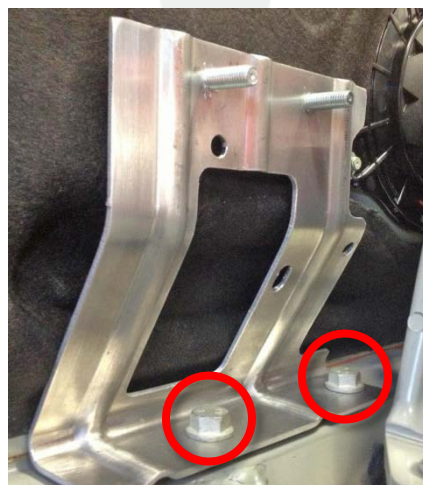
**Figure 18**

23. Install the 2 bolts that secure the new lower bracket (torque 19 Nm) (Figure 18).

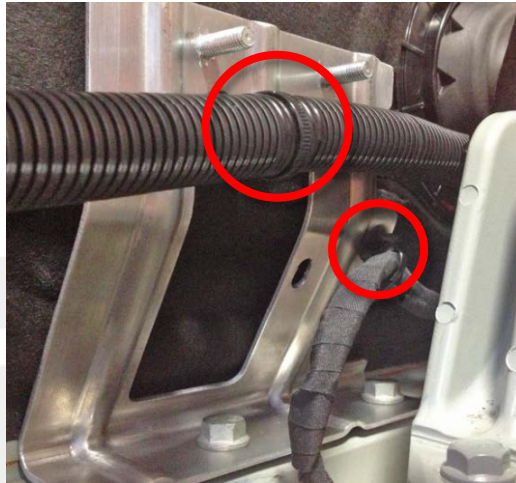
**Figure 19**

24. Install the 2 fir tree clips to the lower bracket (Figure 19).

**NOTE:** If either fir tree clip is damaged, replace with 1015197-00-A. Trim the excess portion of the cable ties.

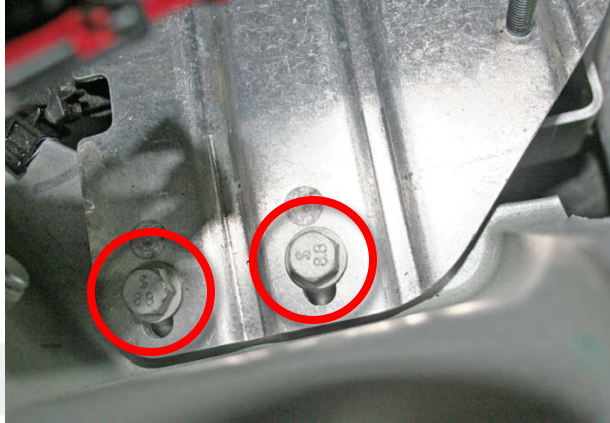
**Figure 21**

29. Install the 2 bolts that secure the upper bracket to the shock tower (torque 6 Nm) (Figure 21).
