Install Pedestrian Protection Sensor Shrouds

Classification	Repair Bulletin	Section/Group	20 - Safety and Restraint	Country/Region	Asia Pacific, Europe
Year	2014-2015	Model	Model S	Version	All

SB-15-20-001

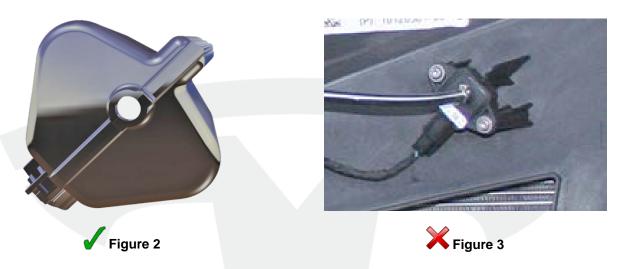
- 1. Inspect the pedestrian protection sensors for shrouds.
 - If shrouds (Figure 2) are installed, no additional work is required; discontinue this procedure.
 - If shrouds are not installed (Figure 3), continue this procedure.

After removing the front fascia for any reason, inspect both pedestrian protection sensors for shrouds (Figure 1). If shrouds are not present, install them over both pedestrian protection sensors.

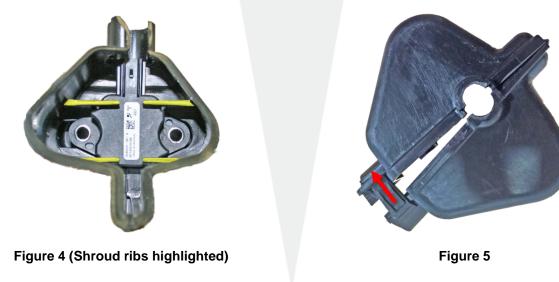
- 2. Install pedestrian protection sensor shrouds.
 - a. Place the shroud over the sensor so that the ribs secure the sensor (Figure 4).
 - b. Fasten the clip at the bottom of the shroud (Figure 5). Ensure that the clip snaps into place.

c. Repeat steps a and b on the other sensor.
