# Replace Seat Belt Pre-Tensioner Rear Bracket Bolt, Model X

<b>Classification</b>	Campaign Bulletin	<b>Section/Group</b>	20 - Safety and Restraint	<b>Country/Region</b>	United States
<b>Year</b>	2016	<b>Model</b>	Model X	<b>Version</b>	Founders

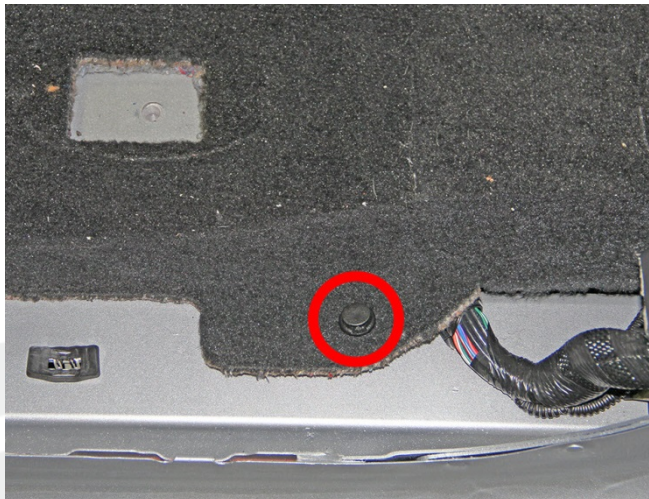
Figure 1

3. Release the push clip that secures the 1<sup>st</sup> row carpet to the body (Figure 1).

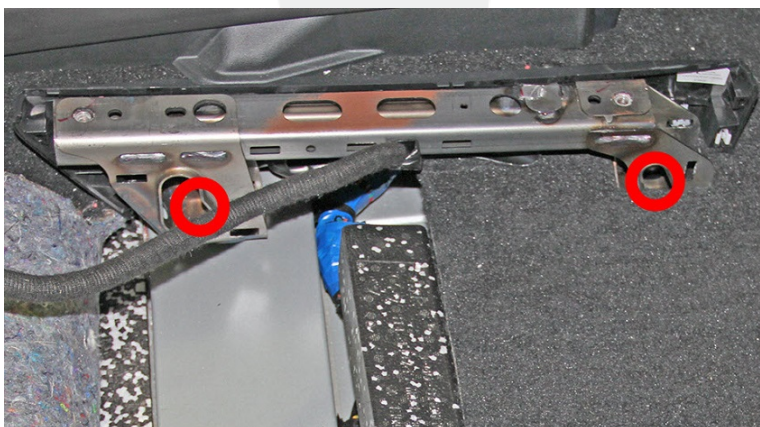
Figure 2

4. Use a trim tool to release the clips that secure the inboard and outboard covers from the inner seat riser.
5. Remove and discard the 2 bolts that secure the inner seat riser to the body of the vehicle (torque 34 Nm) (Figure 2).

**⚠ CAUTION:** The inner seat riser cannot be removed from the vehicle; it is connected to the passenger's inner seat riser.

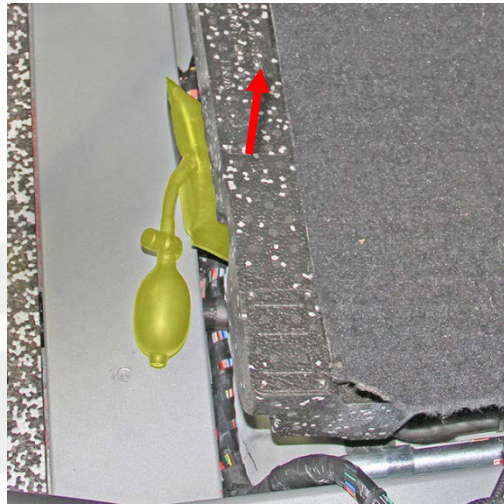
**Figure 3**

7. Use the inflatable wedge to lift the foam block (Figure 3).

**⚠ CAUTION:** Do not overinflate the wedge; lifting the false floor too much can damage it.

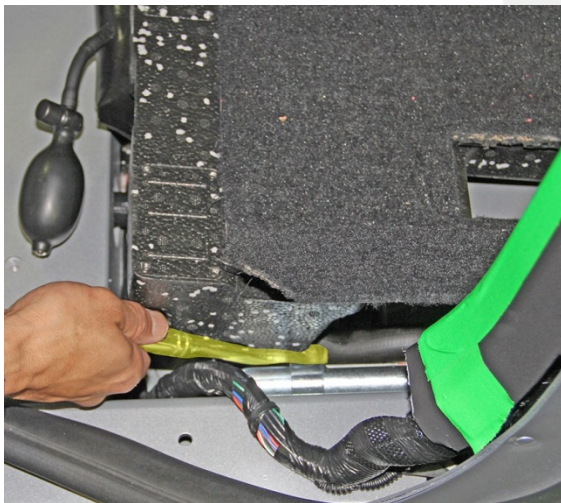
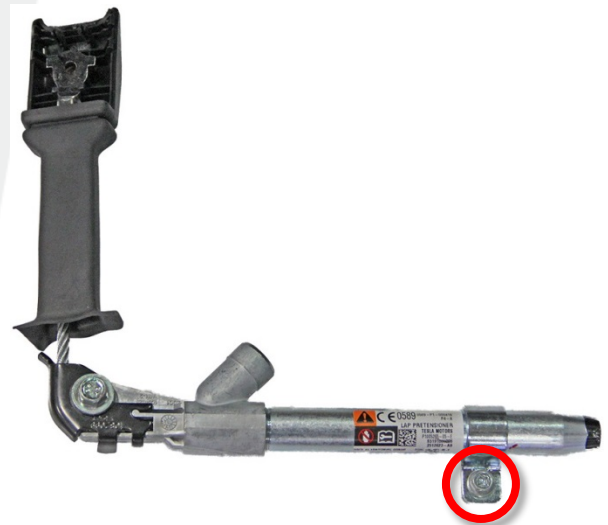
**Figure 4**

8. Remove and discard the bolt that secures the seat belt pre-tensioner support bracket to the body of the vehicle (Figures 4 and 5).

**NOTE:** There is a push nut on the bolt. Discard the push nut and install the new bolt without a push nut.

9. Install a new bolt (torque 5 Nm).
